FLIGHT MEASUREMENTS OF HORIZONTAL TAIL LOADS ON A
TYPICAL PROPELLER-DRIVEN PURSUIT AIRPLANE DURING
STALLED PULL-OUTS AT HIGH SPEED

By Lawrence A. Clousing and William N. Turner

Ames Aeronautical Laboratory
Moffett Field, California

MEMORANDUM REPORT

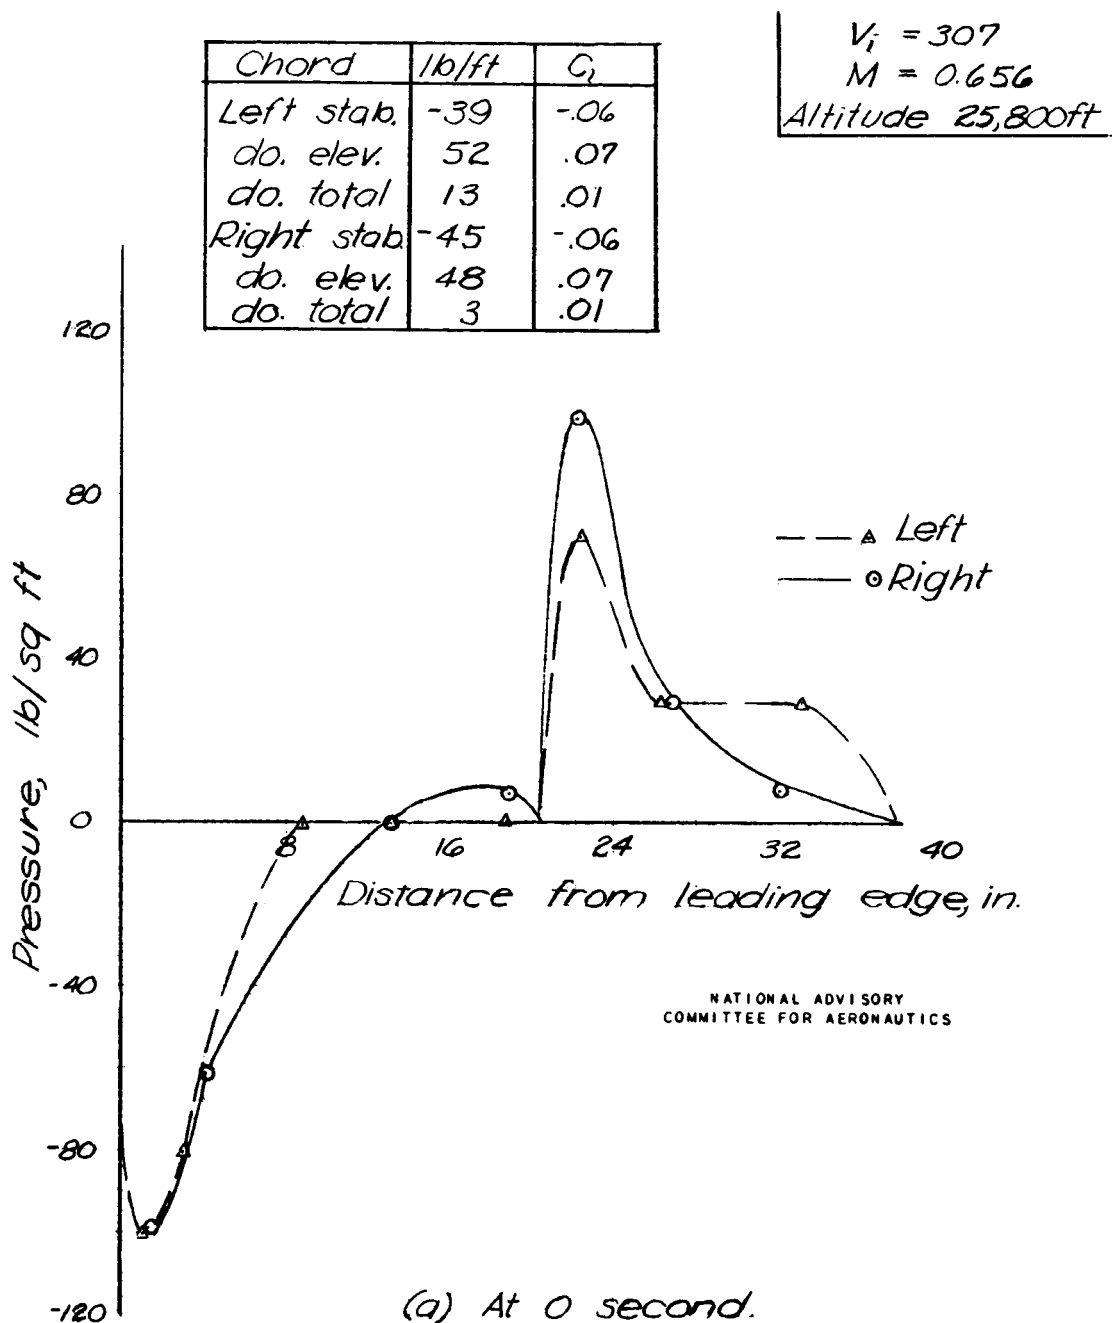
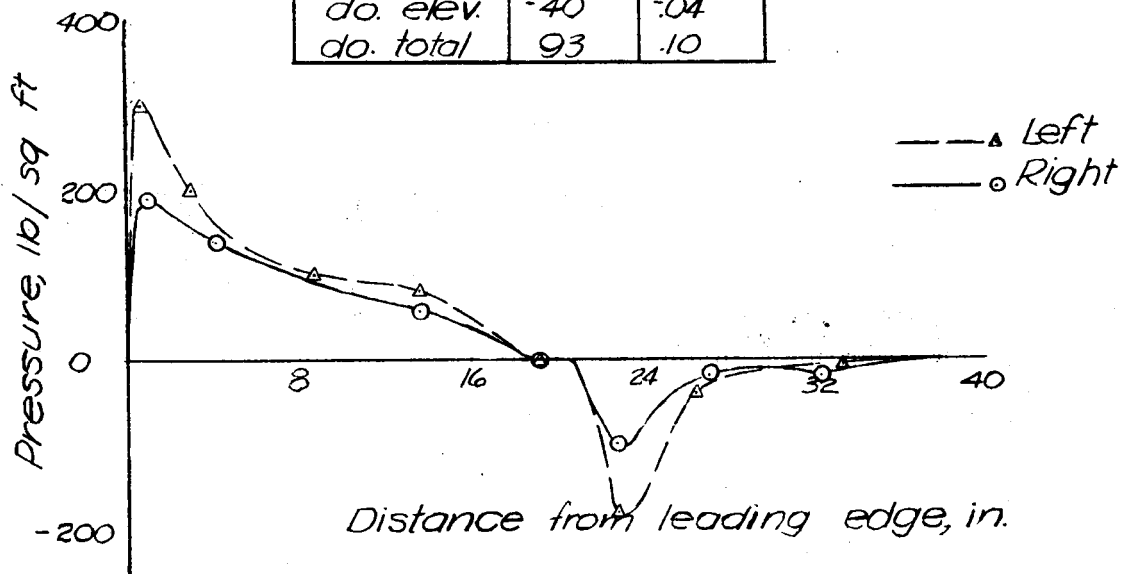
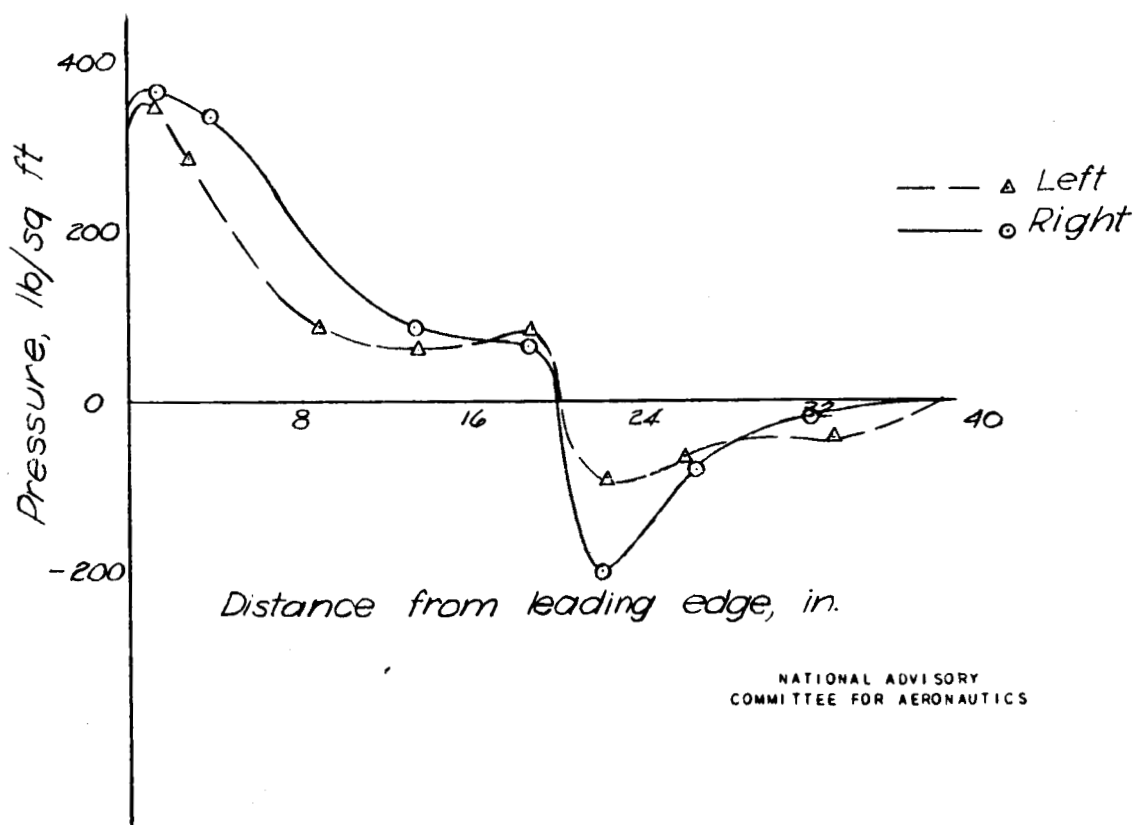
Figure 14. - Chordwise load distribution at 60 percent of semispan in the dive pull-out shown in figure 13.

In figures 13, 14, and 15 it is seen that the airplane was ~~pulled in~~ until a very violent stall occurred at a lift coefficient of 1.01 and a Mach number of 0.67. The maximum acceleration factor reached was 7.5 at an angle of attack of 19° . The maximum elevator angle used was 11.5° up. The buffeting was apparently about the same on both sides of the tail in this run. Rapid fluctuations of pressure of 300 to 400 pounds per square foot occurred at the leading edge of the stabilizer during the buffeting. The maximum recorded pressures and unit span loads in this run are listed in the following table:

Figure 24 shows the loading conditions for which the horizontal tail surface was designed. Comparison of this figure with the actual flight measurements (figs. 5, 8, 11, and 14) shows that in many instances the unit loads actually measured on the stabilizer in flight were not only considerably in excess of the design unit loads, but that they occurred in a direction opposite to the design loads. At the leading edge of the elevator, the design unit loads were not exceeded in the pull-outs, at least not at the particular spanwise stations at which measurements were made. However, it was the elevator and a fitting supporting the elevator that failed and not the stabilizer.

loads caused much more severe structural strain than the same loads would have caused if applied under static conditions. In the last pull-out, in which the structural failure occurred (figs. 13, 14, and 15), the buffeting was more severe than in any previous maneuver. In this pull-out an attempt had been made to insure absolutely that the maximum acceleration factor possible to attain had been obtained. A strong pull force was exerted on the stick even after heavy buffeting had set in. A slightly greater elevator angle was used than in the previous pull-outs. It should be realized, too, that the loads which were measured during the buffeting condition may actually have been somewhat greater than those recorded, due to lag in the pressure lines.

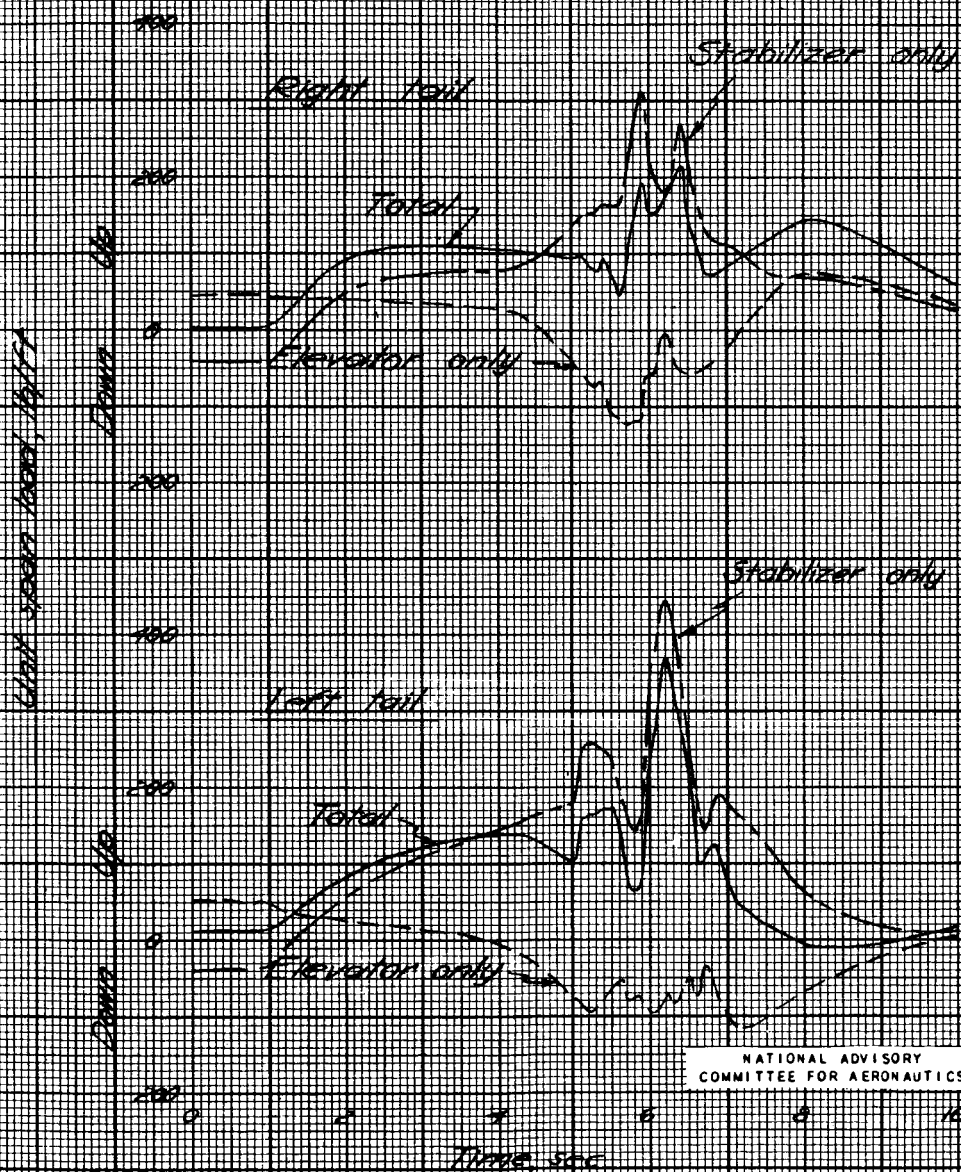
Figure 15 - Time history of the unit span load at 60 percent semispan during the dive pull-out shown in Figure 13

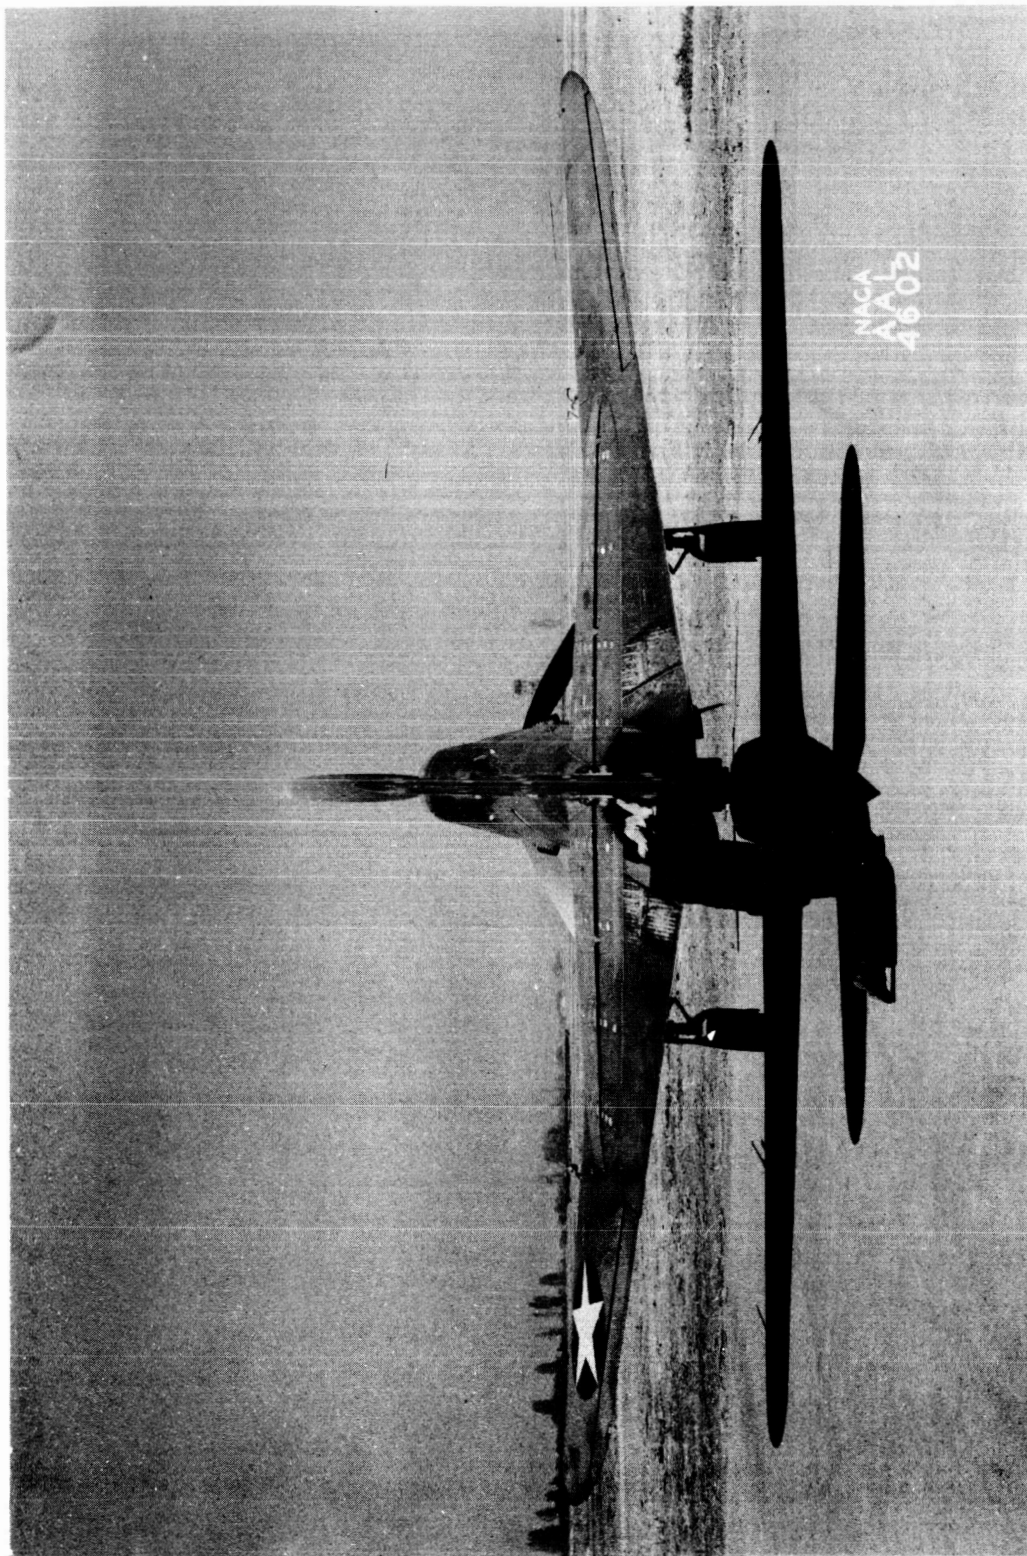
The principal failures were on the left side of the tail, although failure had also started on the right side. A rear view of the airplane with undamaged tail is shown in figure 16, and views of the principal failures are presented in figures 17 to 23. The left elevator had buckled downward at about the third outboard row of orifices (figs. 17, 18, and 19), cracking the elevator spar (fig. 20). The elevator nose balance had been forced downward severely enough to break the elevator nose rib on each side of the tail just inside the outboard hinge fitting (figs. 21 and 22). The left stabilizer rear beam was cracked at the inboard hinge bracket, and the two top bolts holding the bracket to the stabilizer rear beam had been sheared completely (fig. 23). Other miscellaneous failures of various degrees of severity occurred to both the stabilizer and elevator structure in the immediate vicinity of all the hinge brackets.

Figure 16.- Rear view, test airplane as instrumented for tail-load flight tests, showing undamaged tail surfaces.
